Valley Rural Electric Cooperative, Inc.

Valley crews complete Frankstown Substation improvement work

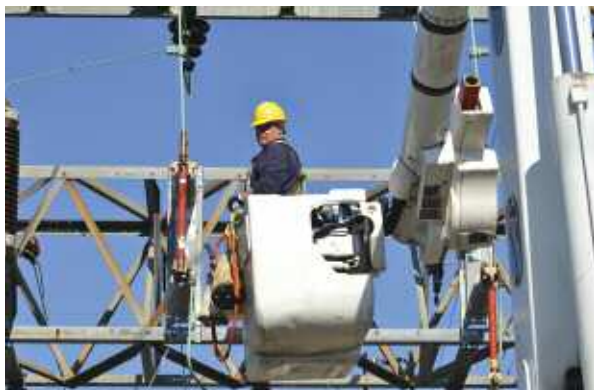
AT LEFT: Journeyman Lineman Bill Bogel, from the Martinsburg District, completes installation of new expulsion fuses at the Frankstown Substation as part of a day-long improvement project. The substation is located along Scotch Valley Road, right.
